DEMONSTRATION REPORT

National Weather Radio (NWR) Nautel Transmitter Installations

August 2010

**U.S. DEPARTMENT OF COMMERCE
National Oceanic and Atmospheric Administration
National Weather Service/Office of Operational Systems
Field Systems Operations Center/Test and Evaluation Branch**

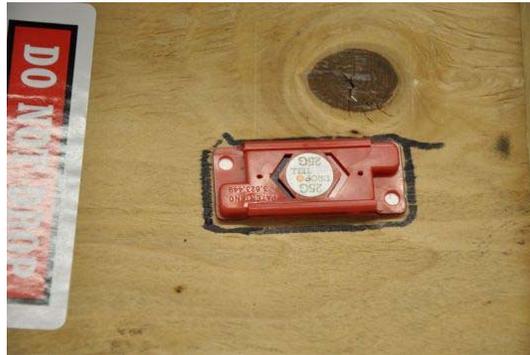
Figure 1 - Drop Indicator Activated

- b. The TXA displayed 0W on the front panel and 0W on output. TXB displayed 380W on the front panel and on output.
- c. Upon further inspection, the staff discovered that the main unit packing crate indicated a 25G drop and that impact has occurred. The staff then proceeded to open both the TXA and TXB units and discovered that the power supplies have been pushed back from the front to the back. One of the units (TXA) even had one of its power supply pins sheared off and missing. The following pictures in Figure 1 through Figure 3 display drop indicator and some of the damaged parts of the transmitter.

- b. Sites should check the dropped shipment indicators before accepting transmitter shipments and before actual installation. The dropped shipment was discovered at Rocky Mount, NC only after the crates have already been accepted and opened and installation has already proceeded.

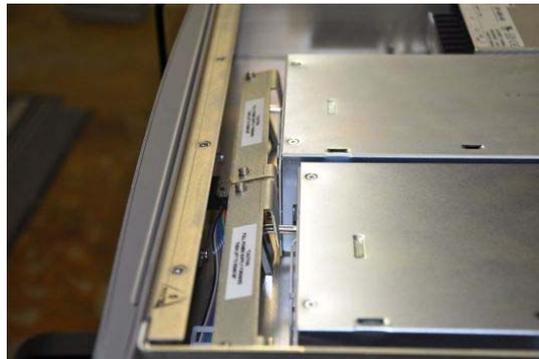
Figure 2 - Power Supply Pushed In

The test team then proceeded to call a meeting with Nautel and Ron Vaillant (OPS17) to discuss the failures and the group agreed that current problems could be attributed to the damaged units during shipping. Kirk Zwicker from Nautel agreed to ship a new transmitter to the Rocky Mount site to ensure that the site receives a brand new transmitter and to mitigate any other problems in addition to the damaged power supplies.
