## 5. Design improvements initiated by the EQT

## 6. Design improvements initiated by experience of product's developers

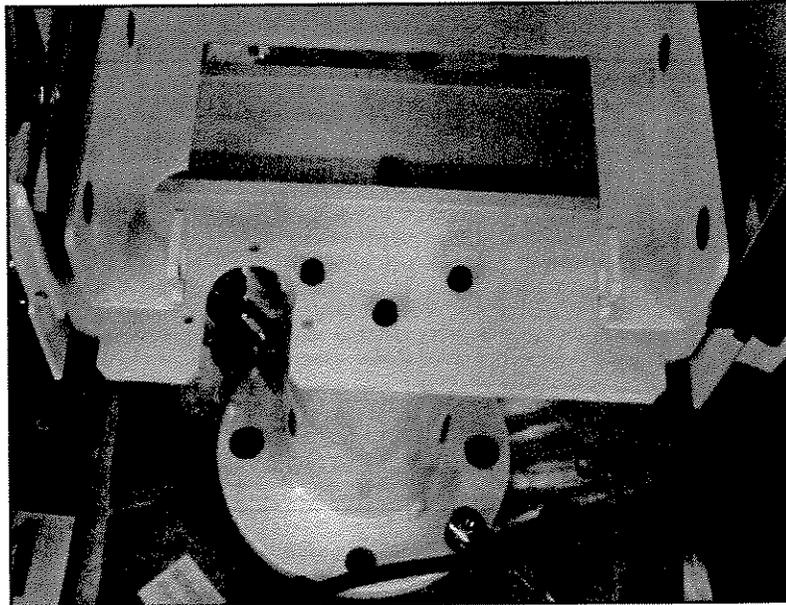
The pedestal designed for CL31ASOS ceilometer preproduction units passed the EQT. However, certain concern on its robustness in field use was raised. The pedestal is made far more robust by implementing following improvements:

- Support ribs are added,
- Thickness of fork plate is increased, and
- Welded joints are replaced by screw fastenings

**Modified pedestal**

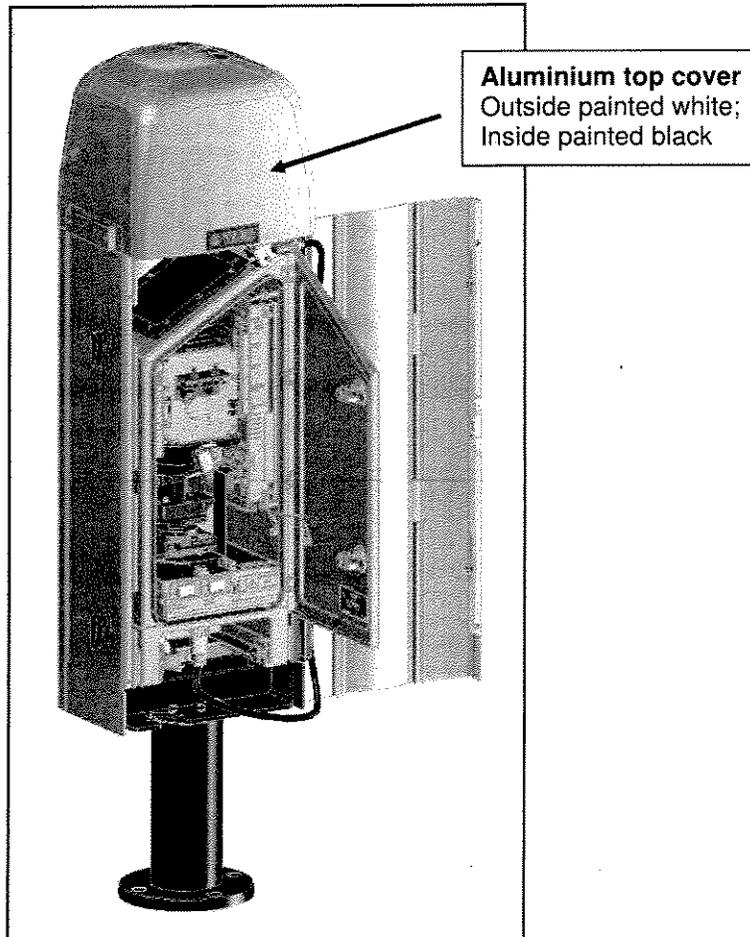
CL31ASOS

Ceilometer top cover material is changed from plastic to painted aluminium. New design top cover with added ferrite toroid on the receiver coaxial cable provides excellent EMI tolerance.

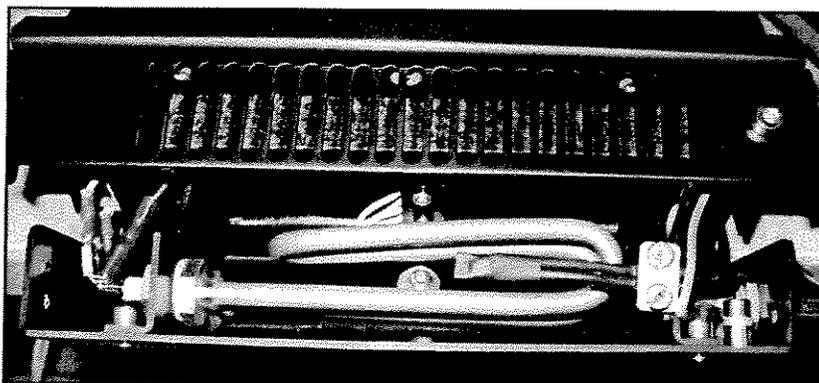
Thermistor mounting and its insulation in the window blower was a concern in both COTS ceilometer and CL31ASOS preproduction ceilometers.

Old design of the thermistor mounting in the blower; with cover grating opened

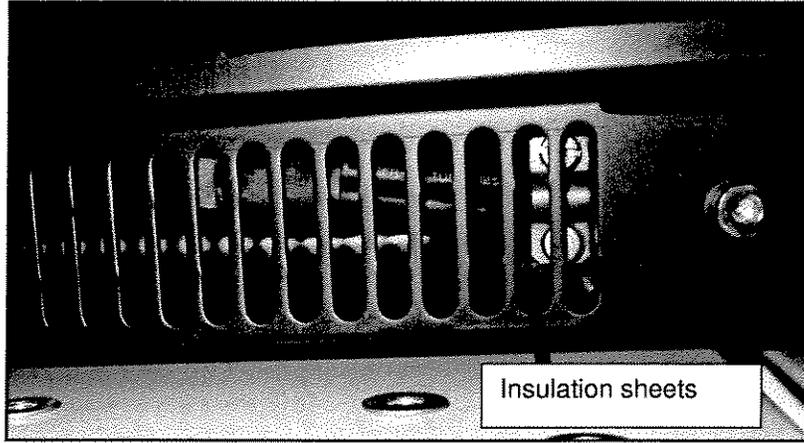
A small clamp retaining the thermistor at its place from its wires was redesigned. The improved clamp has a bend in the middle. Also, small insulator sheets were added on the both sides of the thermistor wire. All these were done in order to fasten the thermistor without a risk of accidentally peeling or puncturing the thermistor wire skin and consequently short-circuiting the thermistor, furthermore disabling the outside heater.

**Improved arrangement in blower design**

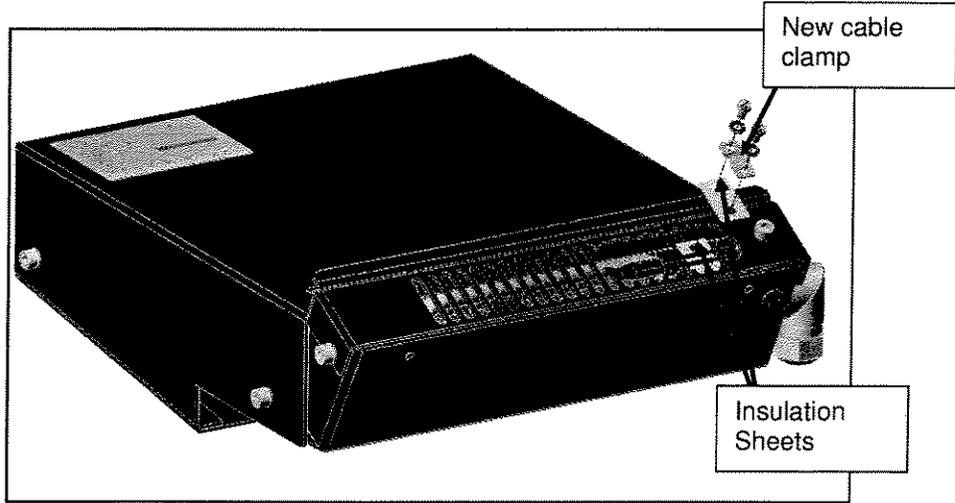
**Exploded view of changes in blower unit**

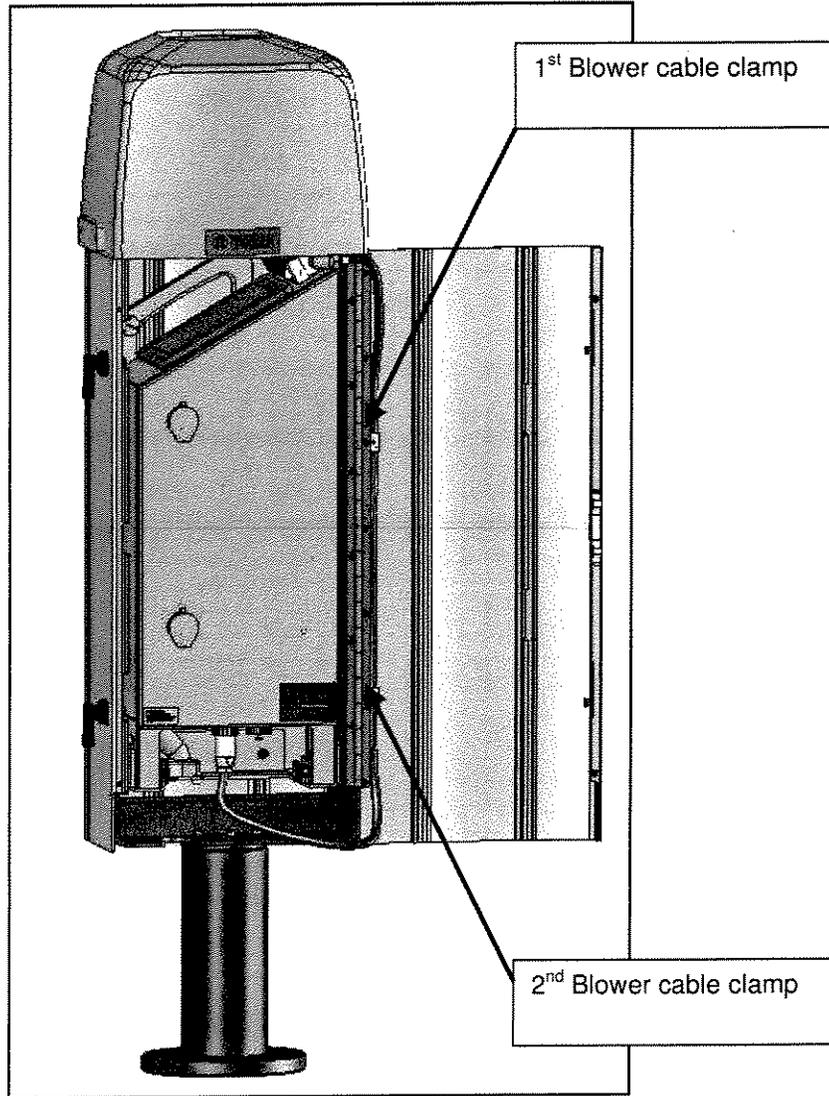
Another cable holder/clamp is added to the inner surface of the radiation shield door.

**Blower Cable clamps**

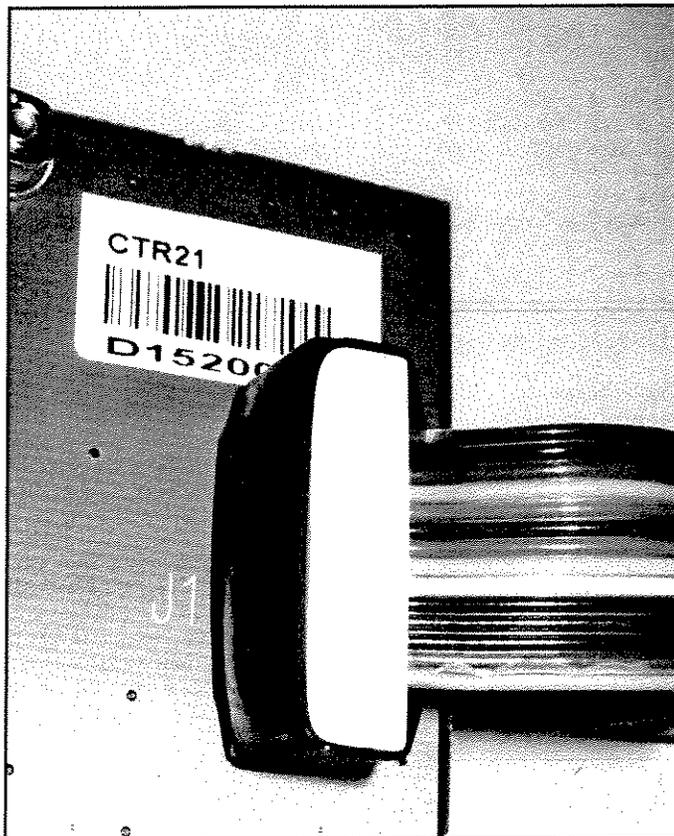
Because of the old ribbon cable connector will be obsolete year 2008; a new type connector is taken into use in CLR321 Receiver.

New ribbon cable connector at the ceilometer receiver
